# Manhole Inspection Summary

Manhole # S47G2\_026MH

Record Plat: **47G2** Node: **026** Status: **New Manhole (Not in GIS)** Insp Date: **4/17/09 12:00 AM**

**Location** Address: **4200 Morrison**

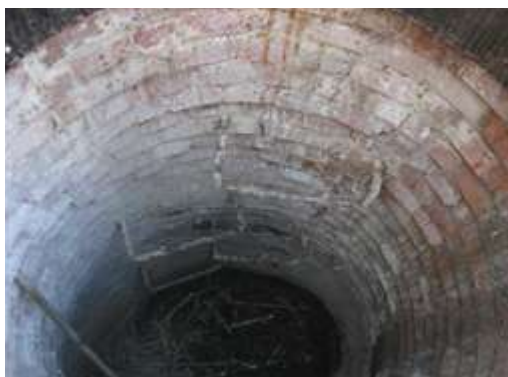
Steps

**Steps** Count: **4** Missing: **0** ☐ Corroded

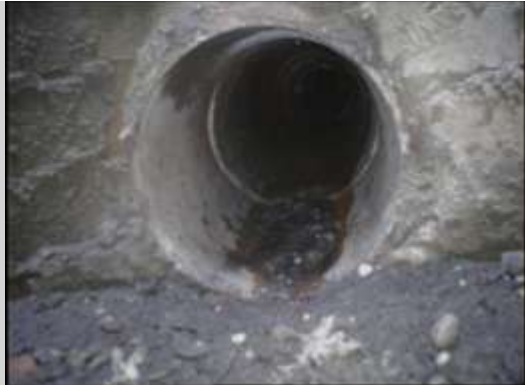
12 O'Clock Outflow

6 in. Circular Gravity Sewer  
Pipe Out @ 12 O'Clock

Infiltration: **None** Pipe Seal Cond: **Sound**
